# SAFETY RECALL

Communication #: R-24-02

## SUBJECT: WINCH LOOSE GROUND CONNECTION

Polaris has determined that a loose ground connection for the winch may occur on some Model Year 2024 Ranger XD 1500 and Crew XD 1500 vehicles. A loose winch ground connection in combination with winch operation may pose a fire hazard and risk of serious injury.

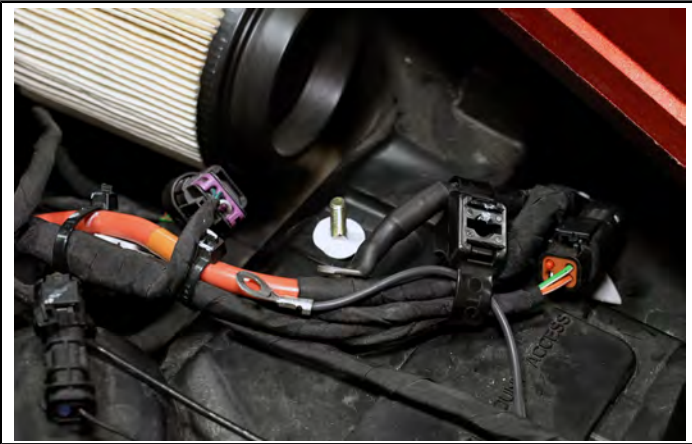
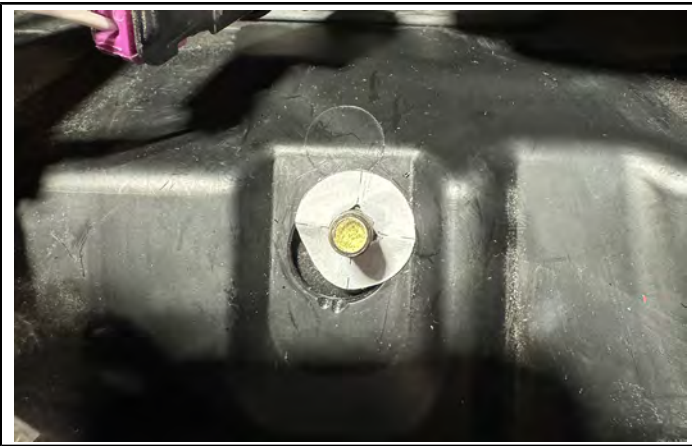
4. Print and cut out the template attached to this document. Place the template over the center of the ground stud. Alternatively, a washer with a 3/4 in (19 mm) outer diameter, centered on the stud, can be used as a template.

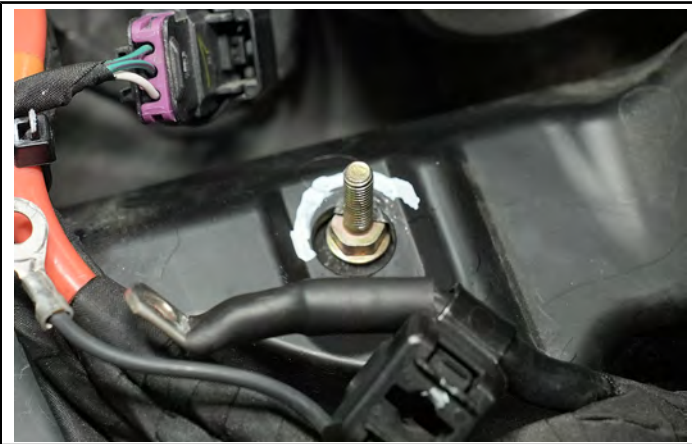
5. Using a paint pen, trace the outline of the template on the plastic of the under hood liner.

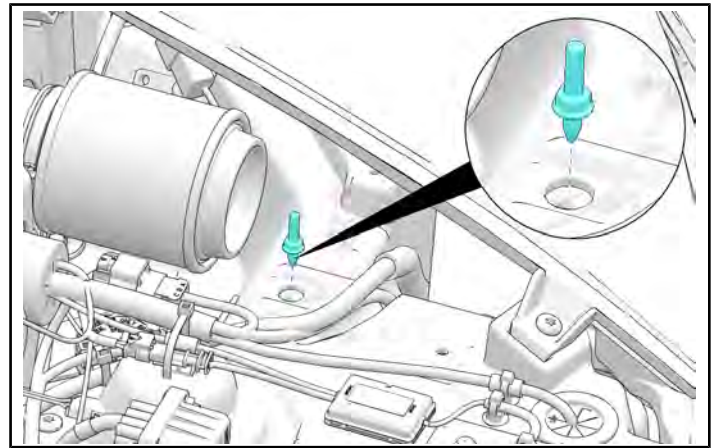
6. Remove the ground stud.

If the under hood liner is contacting the ground stud and preventing it from being removed, remove plastic material until the ground stud can be removed.

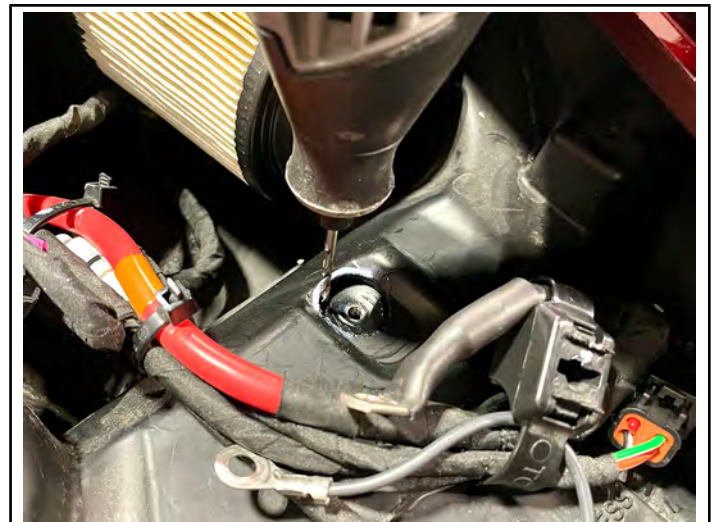
7. With the ground stud removed, remove any material that is inside of the template outline on the plastic of the under hood liner.

Use a Dremel, 3/4 in (19 mm) hole saw, sharp knife, etc. to remove any material that is inside of the template outline.

Trim plastic hood liner only. Do not damage metal frame underneath or any other nearby components.

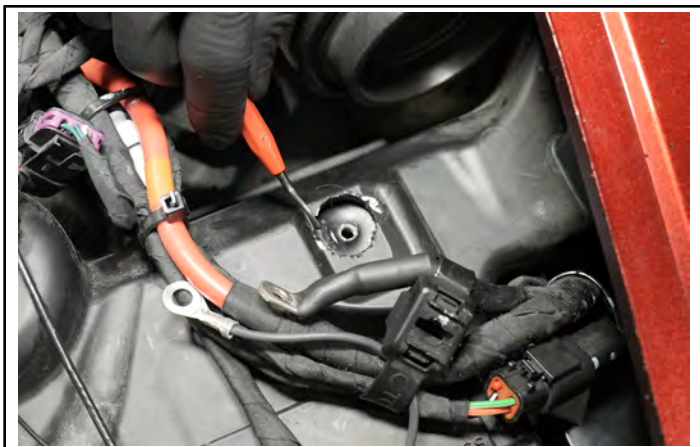
8. Debur the hole using a deburring tool.

The diameter of the hole should be at least 3/4 in (19 mm) after removing the material.

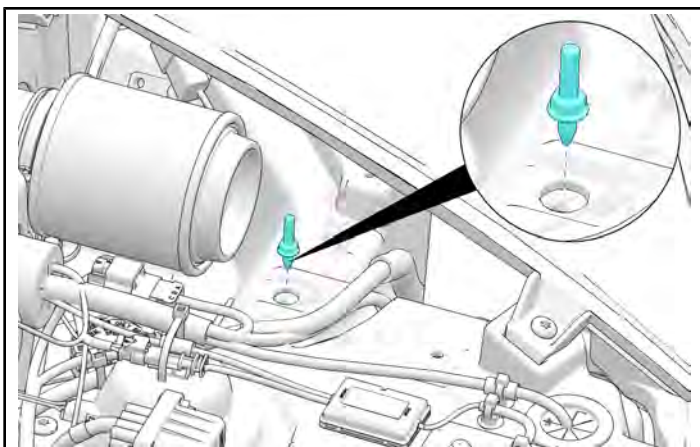
9. Vacuum debris and remains of plastic from the vehicle.

10. Inspect ground stud, winch ground cable, and antenna ground cable (if equipped) for debris, corrosion, plastic remnants, melting and arcing damage. Clean with a wire brush if necessary and replace any damaged components.

11. Install the ground stud.

Ground Stud:  
**11 ft-lbs (15 N·m)**

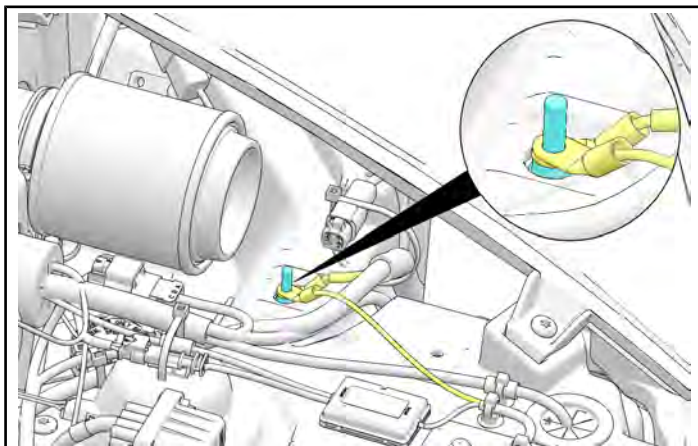
12. Install winch ground and antenna ground cable (if equipped) onto the ground stud.

When installing the winch and antenna ground cables onto the ground stud, the winch ground cable must be installed first (on bottom) and followed by the antenna ground cable (on top). Terminals must be offset and clocked so the wire crimps are not immediately on top of each other.

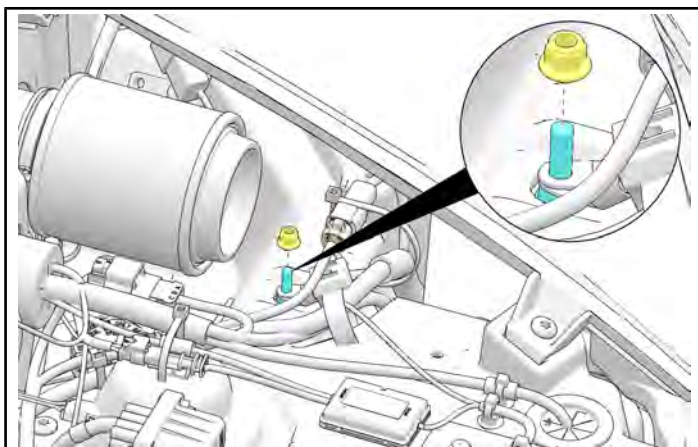
13. Install the nut onto the ground stud to secure the ground cables. Torque nut to specification.

Make sure there is no plastic contacting the ground stud that could be pinched when tightening.

Ground Stud Nut:  
**9 ft-lbs (12 N·m)**
